Please find below my Tree Risk Assessment report for your red maple tree.

REPORT

My assignment was to provide a tree risk assessment for one large red maple tree (*Acer rubrum*) because you were advised by others that this tree may be a liability. The tree is located on property described as: 101 Main Street, Anytown, FL. I conducted my inspection on the afternoon of July 8, 2021 in your presence.

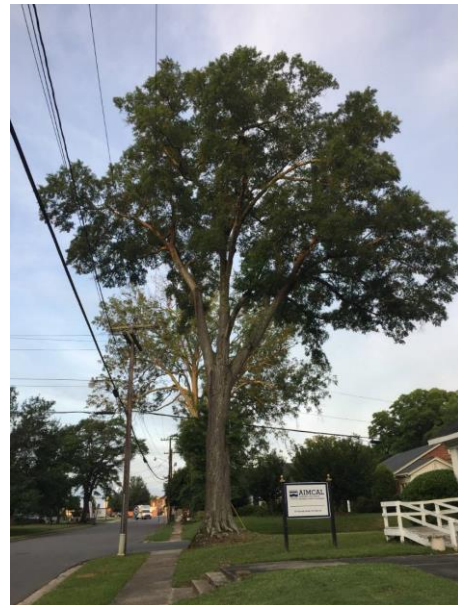
Photo *(optional)*

Defects and conditions of concern. *(required)* A visual examination of the tree revealed several small dead branches and several cavity openings. I struck the tree trunk with a mallet in several locations to listen for tones indicating internal decay. This sounding revealed that the trunk was hollow. I then drilled the trunk of the tree in four locations to determine the amount of solid wood. I found an off-center undulating decay pattern within the trunk and a nominal solid wood thickness of 3.5 inches. The tree also has two cavity openings at the site of old pruning wounds. Heartwood decay is common in old trees and is not necessarily a condition of concern. However, based on our **decay formula** this tree would need a nominal sound wood thickness of 4.6 inches so as not to be a ‘probable’ likelihood of failure. This tree also lacks **response growth** that would lessen the effects of heartwood decay.

The primary concern for this tree is heartwood decay in the lower trunk that is likely to result in a whole-tree failure in **normal weather**. Given the tree’s large size, off-center decay, insufficient sound wood thickness, breaches in the trunk, and height prominence in the landscape, this tree is categorized as **MODERATE RISK** for the adjacent homes, and **LOW RISK** for the powerlines and people.

1. Pruning to reduce the length of 10 of the highest branches by 30%. Unfortunately, the branching nature of elderly red maple trees makes reduction pruning difficult. Many **heading** cuts may be necessary to get the 30% length reduction. The heading cuts may lead to internal branch decay that will need to be monitored and mitigated over time. With this treatment the **residual risk** rating would become **LOW**.
2. Do nothing and continue to monitor the tree with regular inspections.
